DEPARTMENT OF TRANSPORTATION

Quality Assurance and Source Inspection

Contract #: 04-0120F4Cty: SF/ALA Rte: 80 PM: 13.2/13.9File #: 1.28**WELDING INSPECTION REPORT****Resident Engineer:** Casey, William**Address:** 333 Burma Road**City:** Oakland, CA 94607**Report No:** WIR-026956**Date Inspected:** 16-Dec-2011**Project Name:** SAS Superstructure**OSM Arrival Time:** 700**Prime Contractor:** American Bridge/Fluor Enterprises, a JV**OSM Departure Time:** 1530**Contractor:** American Bridge/Fluor Enterprises, a JV**Location:** Job site**CWI Name:** Salvador Marino**CWI Present:** Yes No**Inspected CWI report:** Yes No N/A**Rod Oven in Use:** Yes No N/A**Electrode to specification:** Yes No N/A**Weld Procedures Followed:** Yes No N/A**Qualified Welders:** Yes No N/A**Verified Joint Fit-up:** Yes No N/A**Approved Drawings:** Yes No N/A**Approved WPS:** Yes No N/A**Delayed / Cancelled:** Yes No N/A**Bridge No:** 34-0006**Component:** OBG**Summary of Items Observed:**

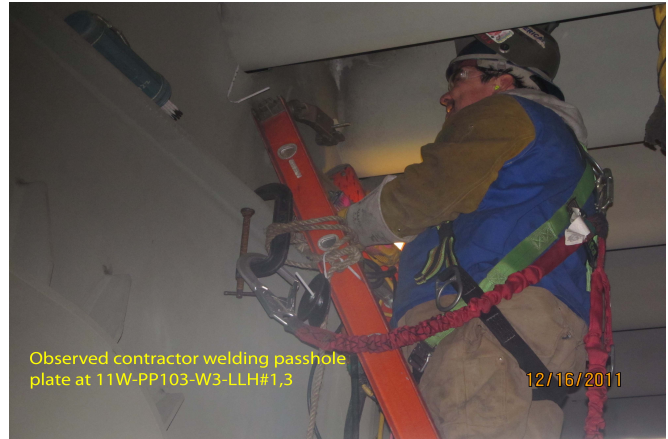
Procedure Specification (WPS) ABF-WPS-D15-1110-R1. This was a Complete Joint Penetration (CJP) weld on a 14mm plate insert at the "A" deck to close the lifting lug deck penetration holes. This work was located at 11W-PP103-W3-LLH#1,3 and was performed in the overhead position from the inside of the "A" deck plate.

During welding, ABF Quality Control (QC) Salvador Moreno was noted monitoring the welding parameters. Welding parameters were recorded as (A=126).
